Mitchell Park Horticultural Conservatory – 2016 Update on Costs and Options for Domes

P490-15654-4

November 10, 2016

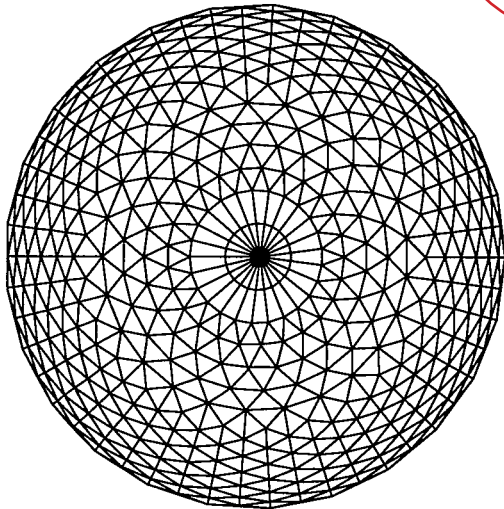
PLAN

FINISH: 70% PVDF Std. Color (2 Coat)
(Non-Exotic, Non-Metallic, Non-Bright White)
FLASHING: 18 GA Aluminum
SLOPING GLASS: 1-1/4" Ins.: 1/4" VE1-2M Clr. H.S.
w/ Low E(2); 1/2" A.S.; 1/2" Clr. H.S. Lam.
w/ .030" Clr. PVB
VERTICAL GLASS: -----

Cost estimate is
for one dome.
